Manhole Inspection Summary

Manhole # S21Y__008MH

Insp Date: **6/19/08 8:32 AM**

Location Address: **2020 breitwert av**

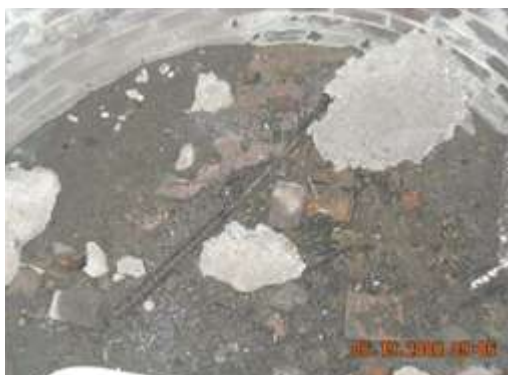
Defect 4

Condition: ☐ Sound ☐ Cracked ☐ Root Intrusion ☐ Deteriorated ☐ Leaks ☒ **Debris**

debris in terminal channel

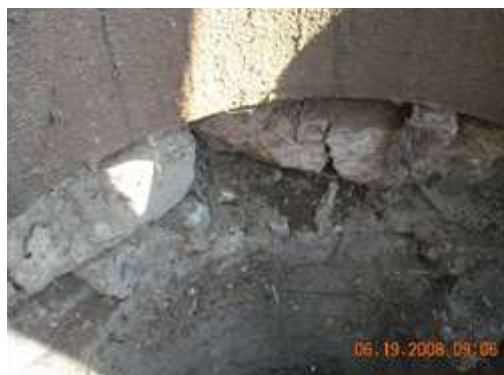
Defect 3

Condition: ☐ Sound ☒ **Cracked** ☐ Root Intrusion ☒ **Loose Brick** ☒ **Deteriorated**

cracked chimney concrete

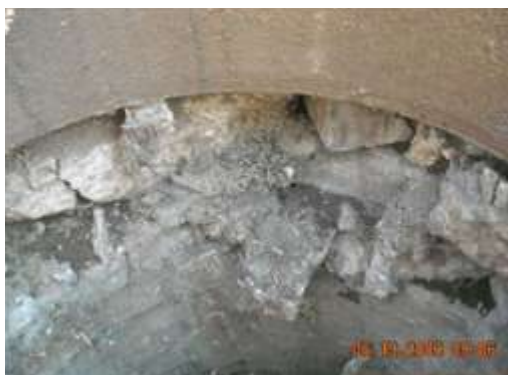
Defect 2

loose chimney material

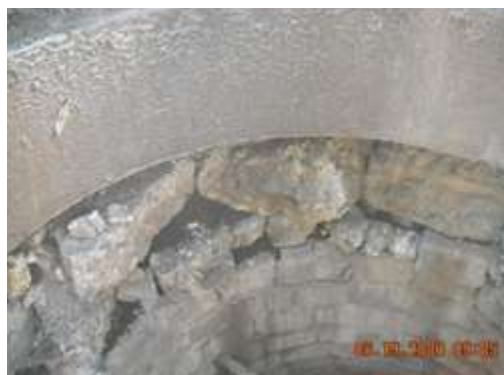
Defect 1

deteriorated chimney

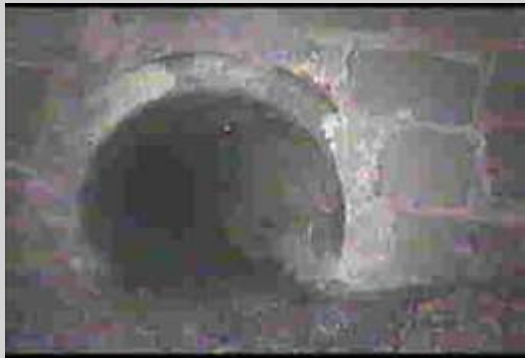
12 O'Clock Outflow

Deposits: ☐ None ☒ **Mud** ☐ Sludge ☐ Debris ☐ Grease

Silt Depth: **2** (in.) Deposits Extent: **Light**

Infiltration: **Evidence** Pipe Seal Cond: **Sound**
